USE OF FRICTION DAMPERS ON ELEVATED WATER TANKS

SUMMARY

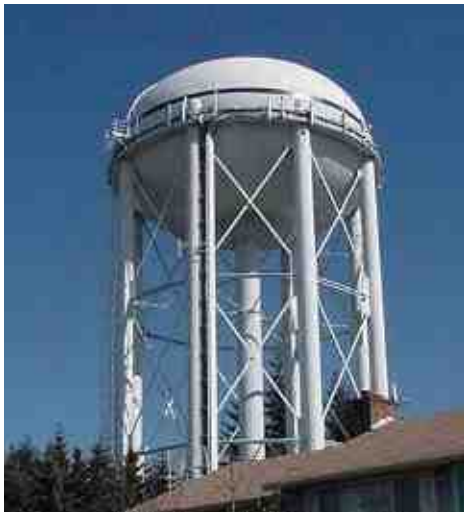
Figure 1. Highlands Reservoir.

The Highlands Reservoir was constructed in 1960 and has a capacity of 750,000 gallons with the top of water level at 135 feet above grade. The welded steel tank is spheroidal in shape, 66'-6" in diameter and 42'-6" in height at its center. The tank is supported by a 72-inch diameter riser column and eight 48-inch diameter pipe columns equally spaced around the perimeter at a 32'-3" radius. The column wall thickness varies from 0.375 inches at the top to 0.406 inches in the middle. The wall thickness for the lower column could not be determined from the drawings, but was assumed to be similar to the middle section.

The diagonal tension-only braces occur in three tier heights with each brace approximately 45 feet long. The braces consist of 6-inch by 2-inch steel flat bar and are welded to steel gusset plates at the pipe column connection. The horizontal struts between the bracing levels consist of built-up channel sections. Both the upper and lower struts consist of a vertical C9x13.4 and a horizontal C12x20.7, stitch-welded together. The columns are each supported by a 4-foot high, 5'-9" square pier that bears on a 2-foot deep, 13'-3" square footing. The 6-foot high pier and footing bears 5 feet below grade.

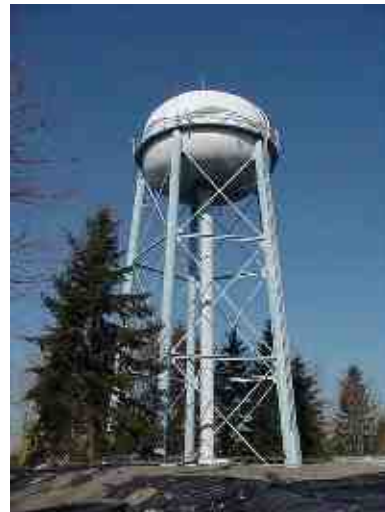
Figure 2. Rolling Hills Reservoir.

The Rolling Hills Reservoir was constructed in 1970 and has a capacity of 300,000 gallons with the top of water level at 115 feet above grade. The tank is torospherical in shape, 45'-0" in diameter and 30'-0" in height at its center. The tank is supported by a 48-inch diameter center column and five 36-inch diameter steel pipe columns equally spaced around the perimeter at a radius of 28'-0". Each perimeter column has a constant wall thickness of 0.406 inches.

The diagonal tension-only braces occur in three tier heights and each brace averages 48'-6" in length. The braces consist of 3 1/2-inch wide by 1 1/4-inch thick steel flat bar and are welded to steel gusset plates at the column connections. Both the upper and lower struts consist of a vertical C10x15.3 and a horizontal C12x20.7, stitch-welded together. The columns are each supported by a 3'-5" high, 6'-0" square pier that bears on a 2-foot deep, 13'-0" square footing.

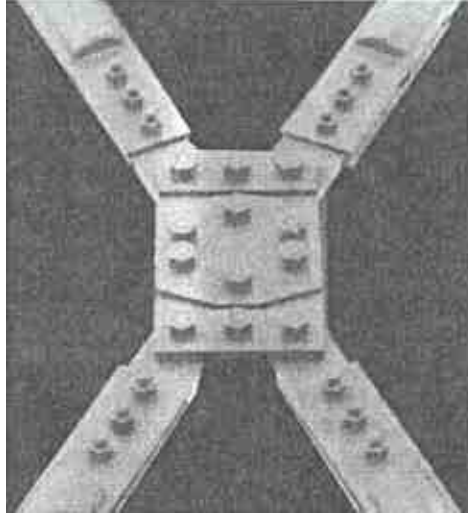
Figure 3. Friction Damper (courtesy of Pall Dynamics, Inc.).

Energy dissipation was evaluated as an alternative approach to the conventional strengthening schemes. Passive energy dissipation is an emerging technology that enhances the seismic performance of the structure by adding damping. The primary use of energy dissipation devices is to reduce earthquake displacement and the corresponding internal forces of the structure. Friction dampers suitable for cross bracing were evaluated to be the primary component to dissipate earthquake energy. The friction damper consists of a series of steel plates that are treated to develop reliable friction surfaces. The plates are mated together with high strength bolts in slotted holes and are allowed to slip at a predetermined load. Refer to Figure 3.

When tension in one of the braces forces the damper to slip, the four outer links are activated, shortening the other brace and keeping it taut. In the next half cycle, the other brace resists forces in tension and activates the damper in the other direction. The friction dampers are displacement-dependent devices that possess rectangular (rigid-plastic) hysteretic loops with negligible fade over several cycles of reversals. The response of friction dampers have an added benefit of being independent of velocity and/or frequency of excitation.

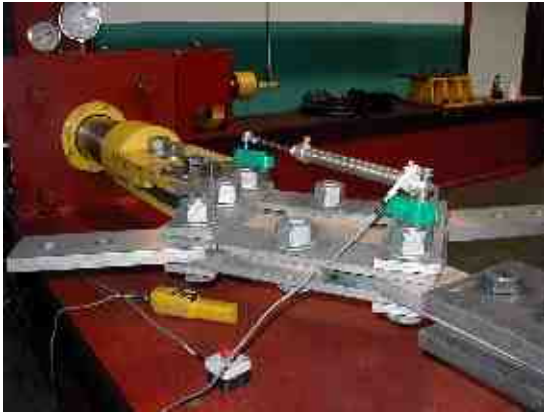
Figure 4. Prototype Testing.

As part of the quality control process, prototype testing was performed on two full-size friction damper devices prior to construction. Each device was loaded with alternating tension and compression forces applied to opposite damper legs for 20 cycles, with each cycle lasting approximately 15 seconds. The cycle was reversed at a point when the distance between the two outermost points of the damper reached the MCE (Maximum Credible Earthquake) stroke. Since friction dampers are not velocity-dependent, the speed at which the dampers were tested is irrelevant.

Pressure readings were taken and recorded by a computer at displacement increments of approximately 0.02 inches, and force-displacement curves were plotted for each test. The capacity of each prototype damper was maintained over the 20 continuous cycles and the variation in the slip load was within the specified tolerance. The temperature of the metal after 20 cycles was approximately 130°F, roughly 65°F above room temperature. Refer to Figure 4 for a photograph of the prototype testing setup.

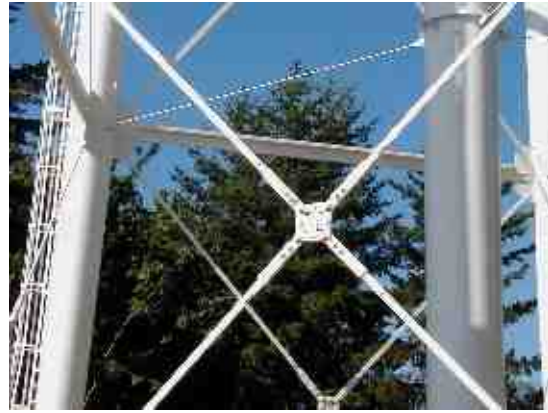
Figure 5. Completed Installation.

A photograph of the completed friction damper installation is shown in Figure 5. The friction dampers were installed on each tank structures using the following sequence:

1. Water storage in each tank was lowered to 60 percent of maximum capacity prior to removing any structural members.
2. The existing braces were cut at the brace intersection and 1-inch steel splice plates were welded on to each side of the severed member ends.
3. Erection brackets with 1-inch diameter A36 threaded rods were installed at the severed brace locations to provide temporary shoring. The pairs of rods were then tensioned simultaneously – tensioning the existing braces, removing the slack, and avoiding subsequent lateral vibrations.
4. The friction damper devices were installed with each leg sandwiched and bolted between the four pairs of splice plates. The process was performed in one bay at a time.
5. The tank was refilled and the slack in the braces was removed using the erection rods and brackets.
